**HEALTH AND SAFETY SURVEY  
CALIFORNIA INSTITUTE OF TECHNOLOGY  
ENVIRONMENTAL HEALTH AND SAFETY SERVICES**

**Laboratory** McCuller Lab **Inspection Date** 10/7/2024  
**Principal Investigator/Supervisor** McCuller, Lee **EH&S Staff Member** Peter King

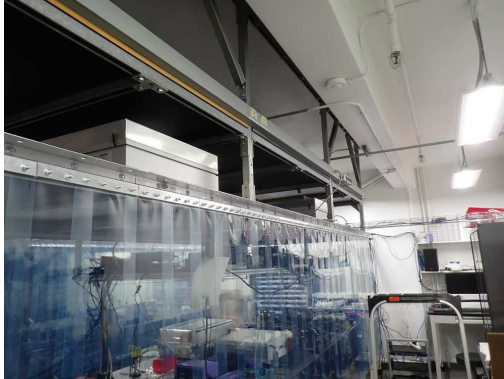
East Bridge B102      Obstructed sprinklers (4 ft. width or length)      The over the table enclosure is blocking the fire sprinkler spray pattern. ☐

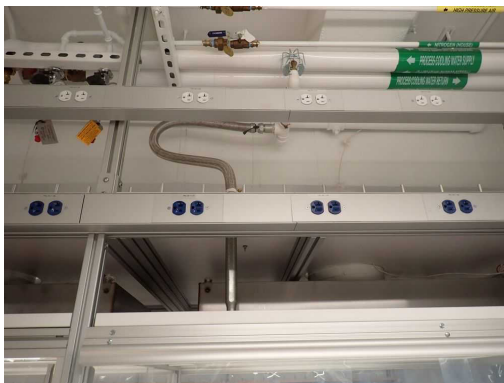
East Bridge B111A      Obstructed sprinklers (4 ft. width or length)      The table enclosure is blocking the fire sprinkler spray pattern. This is true of all the table enclosures in the room(s). ☐

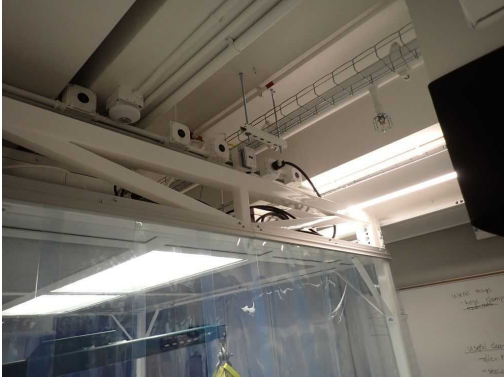
East Bridge	B111B	Equipment/furniture not seismically secured	Once the position of the instrumentation rack has been finalised, it needs to be seismically restrained.	<input type="checkbox"/>
East Bridge	B111B	Laser safety curtains missing fire marshal seal or certificate	The vinyl table enclosure curtains need to have their fire rating documentation on them, or nearby.	<input type="checkbox"/>
East Bridge	B111B	Obstructed sprinklers (4 ft. width or length)	The table enclosure is blocking the fire sprinkler spray pattern.	<input type="checkbox"/>

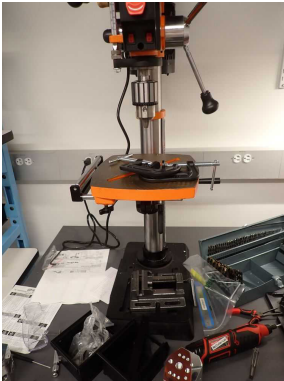
East Bridge	B111B	Fire extinguisher out of certification	Fire extinguisher @7771 needs inspection. Please submit a Facilities Service Request to have this rectified.	<input type="checkbox"/>
East Bridge	B110	No	No safety items noted	<input type="checkbox"/>
East Bridge	B111D	Equipment/furniture not seismically secured	The drill press needs to be secured.	<input type="checkbox"/>
